WAKEFIELD PERMANENT BUILDING COMMITTEE

WAKEFIELD PUBLIC SAFETY MEETING MINUTES

RENOVATIONS AND ADDITIONS TO THE WAKEFIELD PUBLIC SAFETY BUILDING

WAKEFIELD, MASSACHUSETTS April 1, 2021

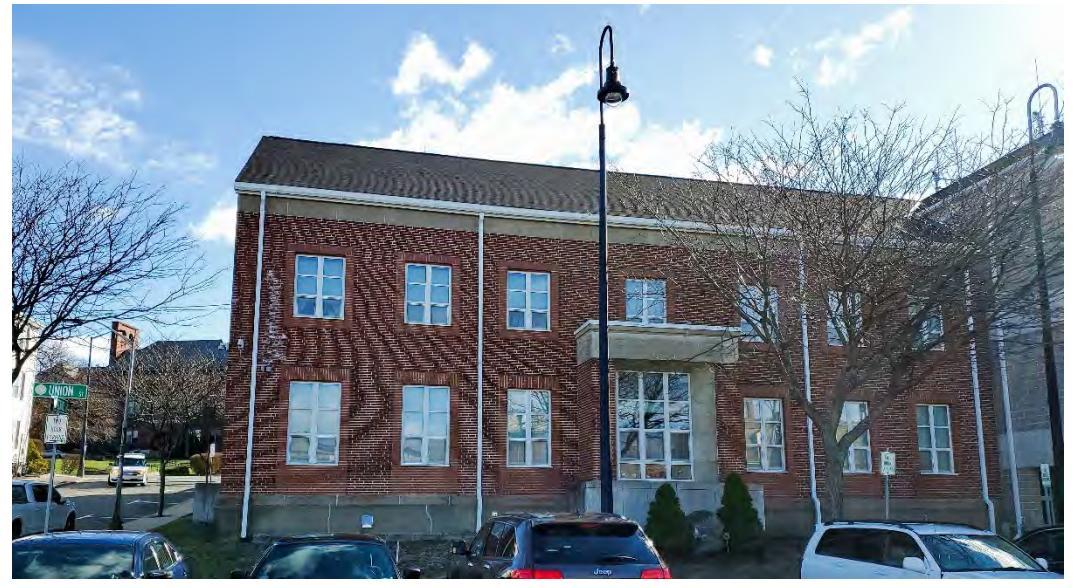
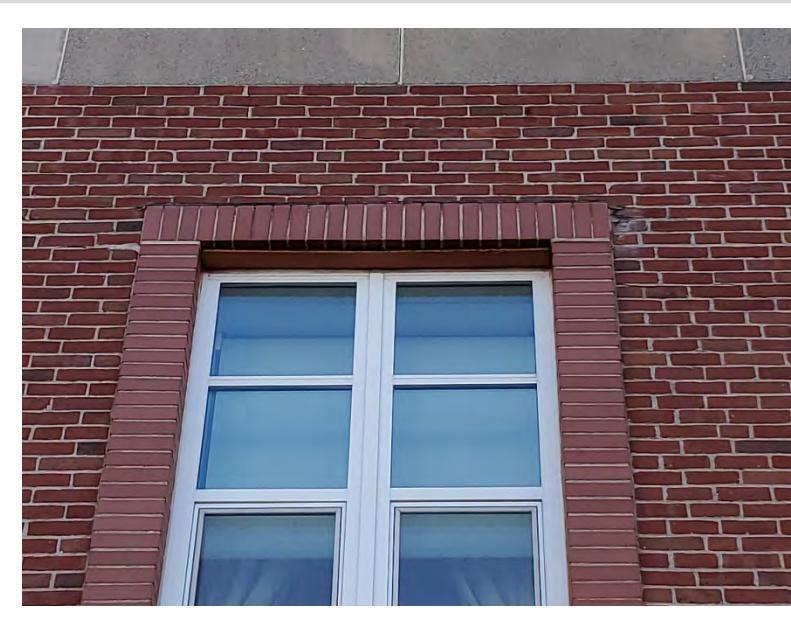
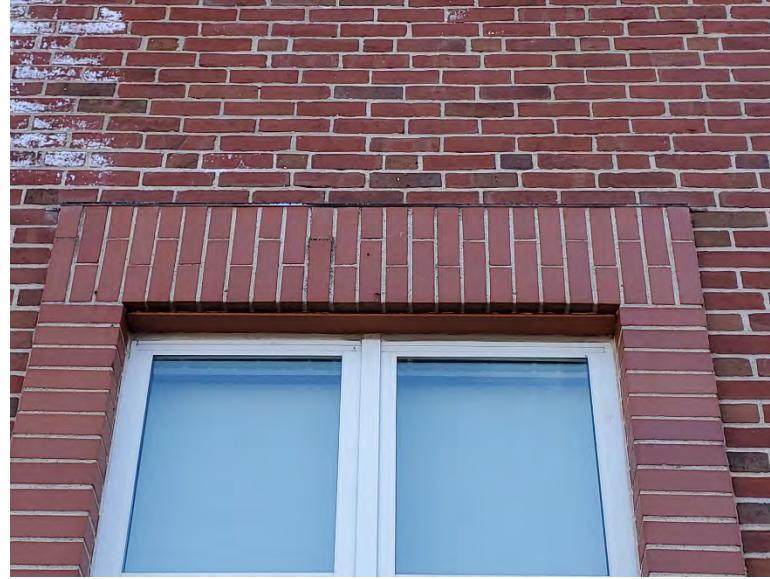
- Masonry in good shape
 - Some visible efflorescence
- Mortar in very good shape

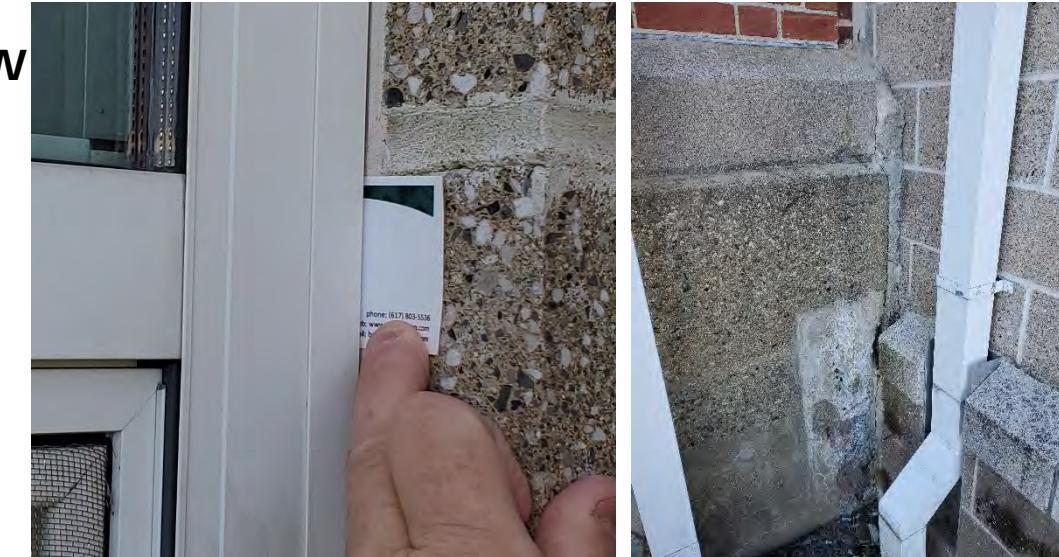
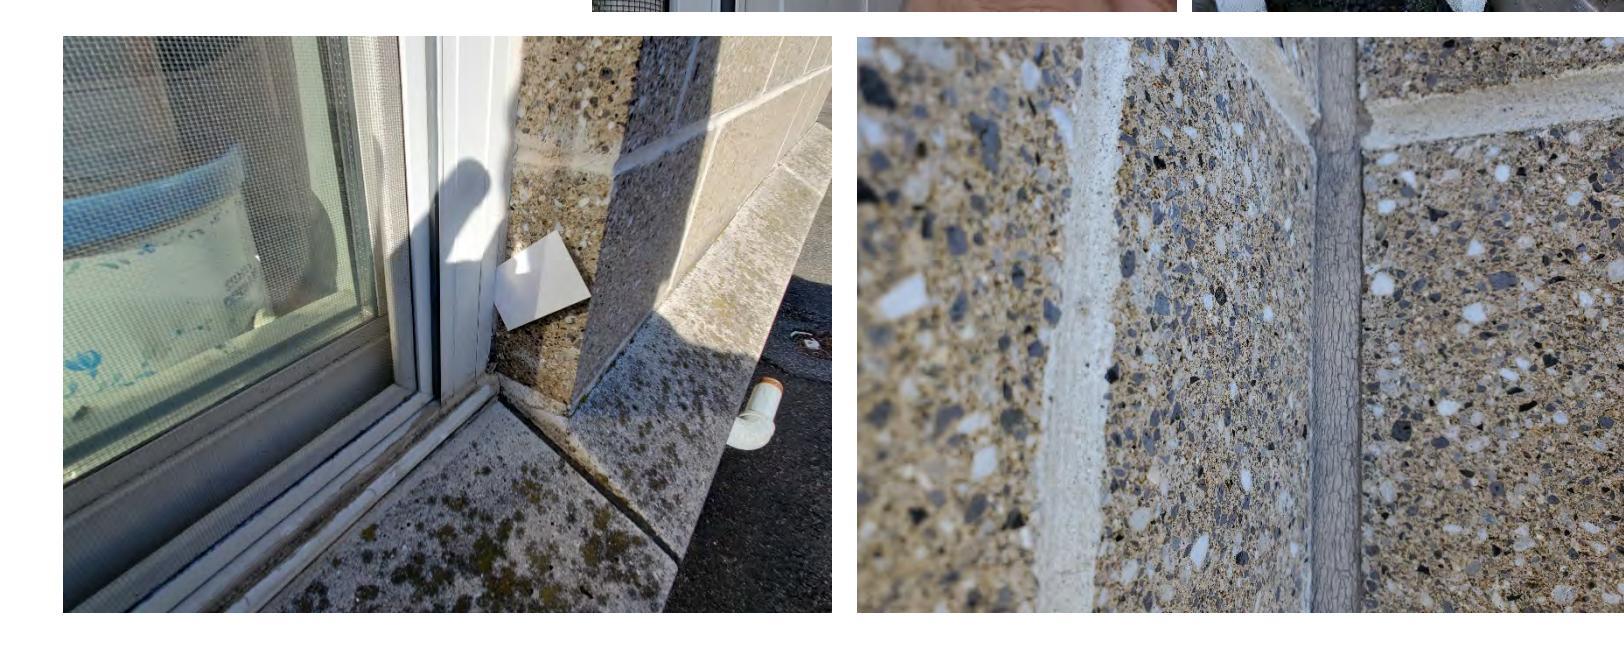
- Sealant is failing or nearing failure throughout building
- Backer rod is probably missing

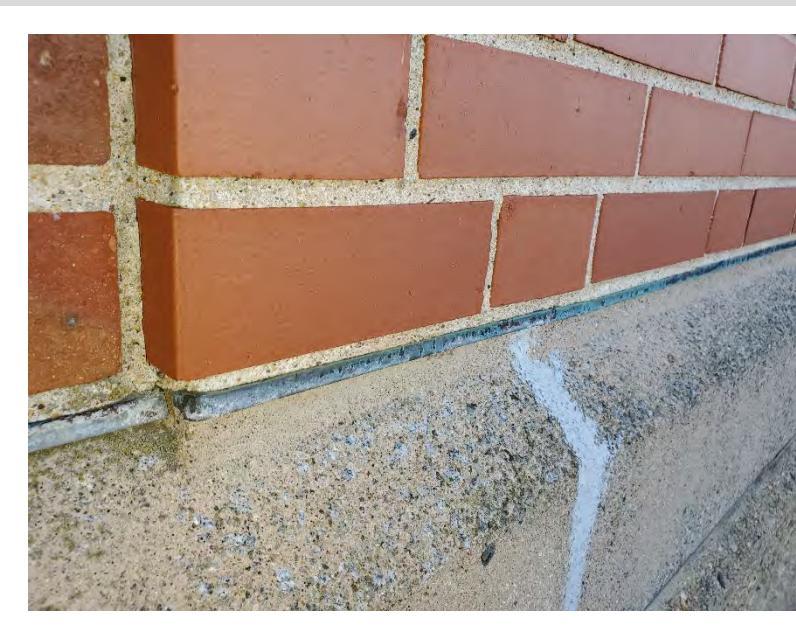
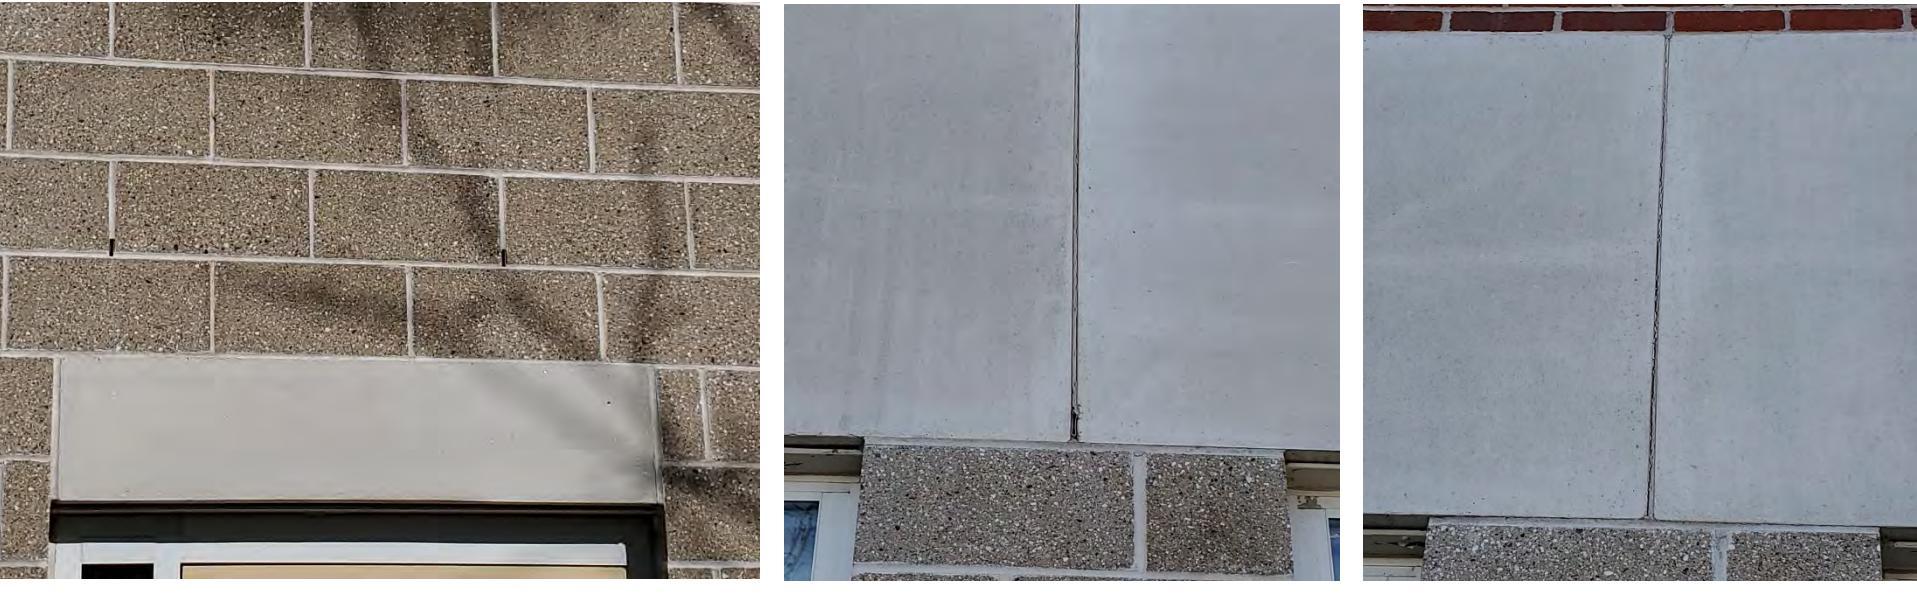
- Weep holes appear inconsistent; missing where they are expected (will review documents)
- Flashing evident but no weeps holes

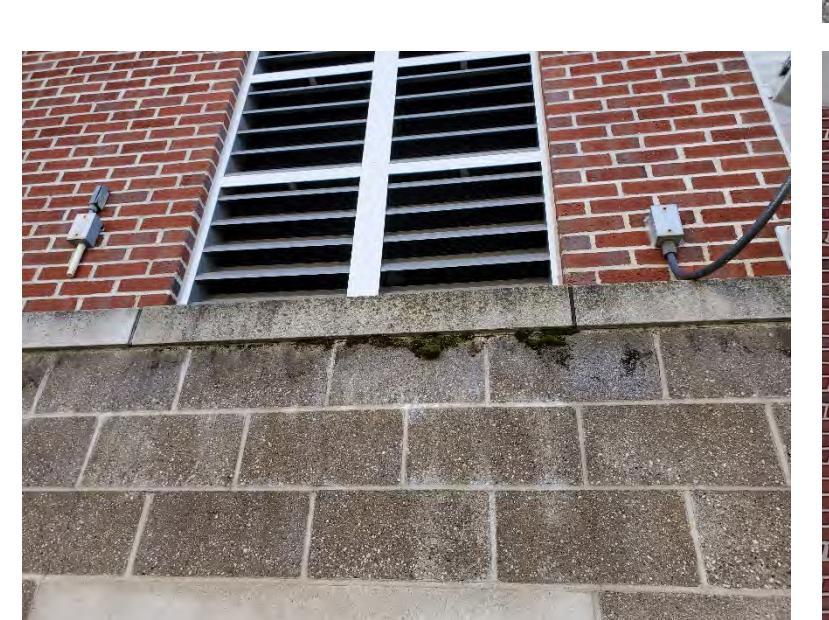
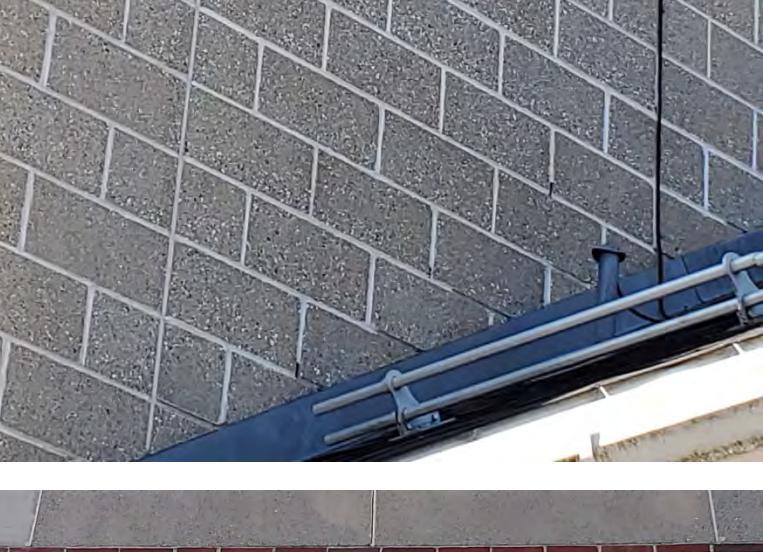
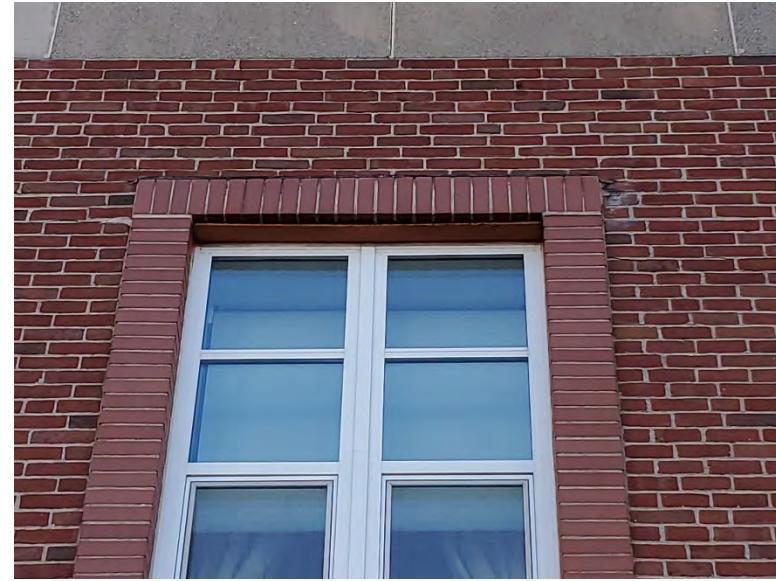
- Other issues
 - Gable at rising masonry wall might require more investigation
 - Lintel deflection

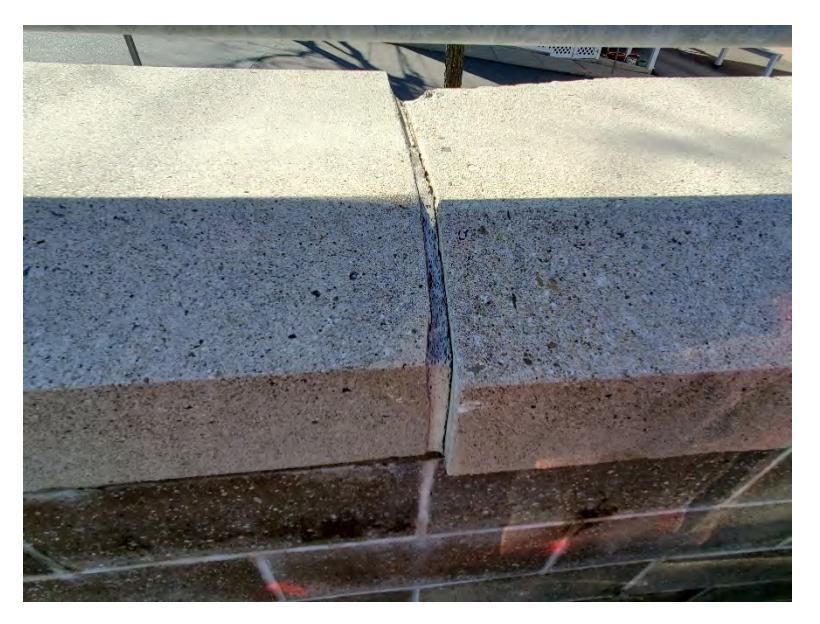
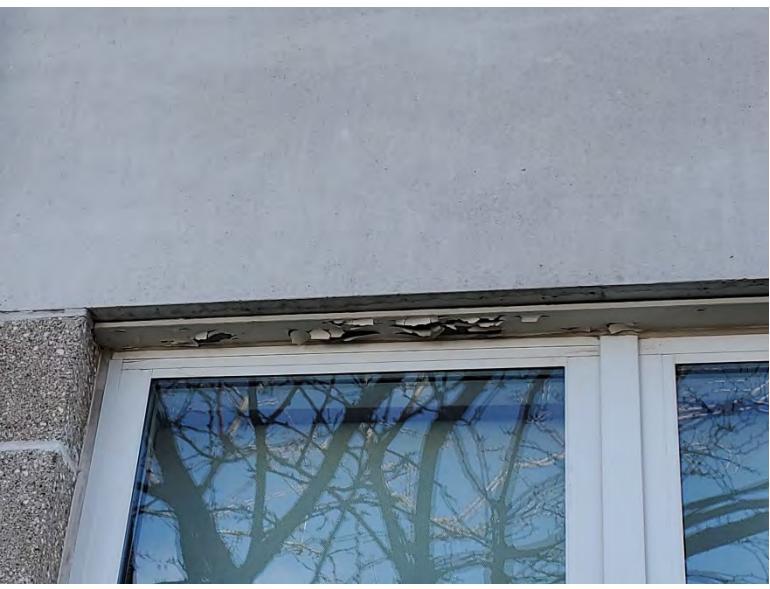
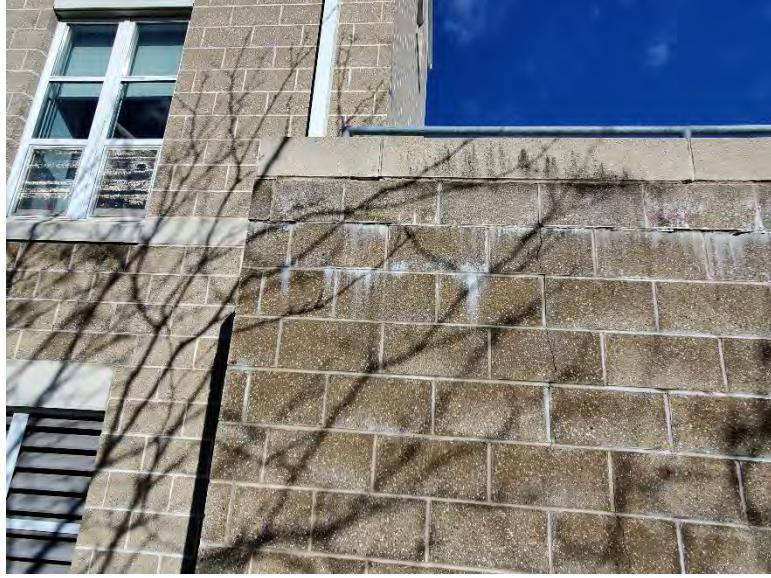
- Other issues
 - Low wall at apparatus apron
 - Paint at lintels
